A 40-Year Performance Assessment of Prestressed Concrete (PC)

I-Girder Bridges In Michigan

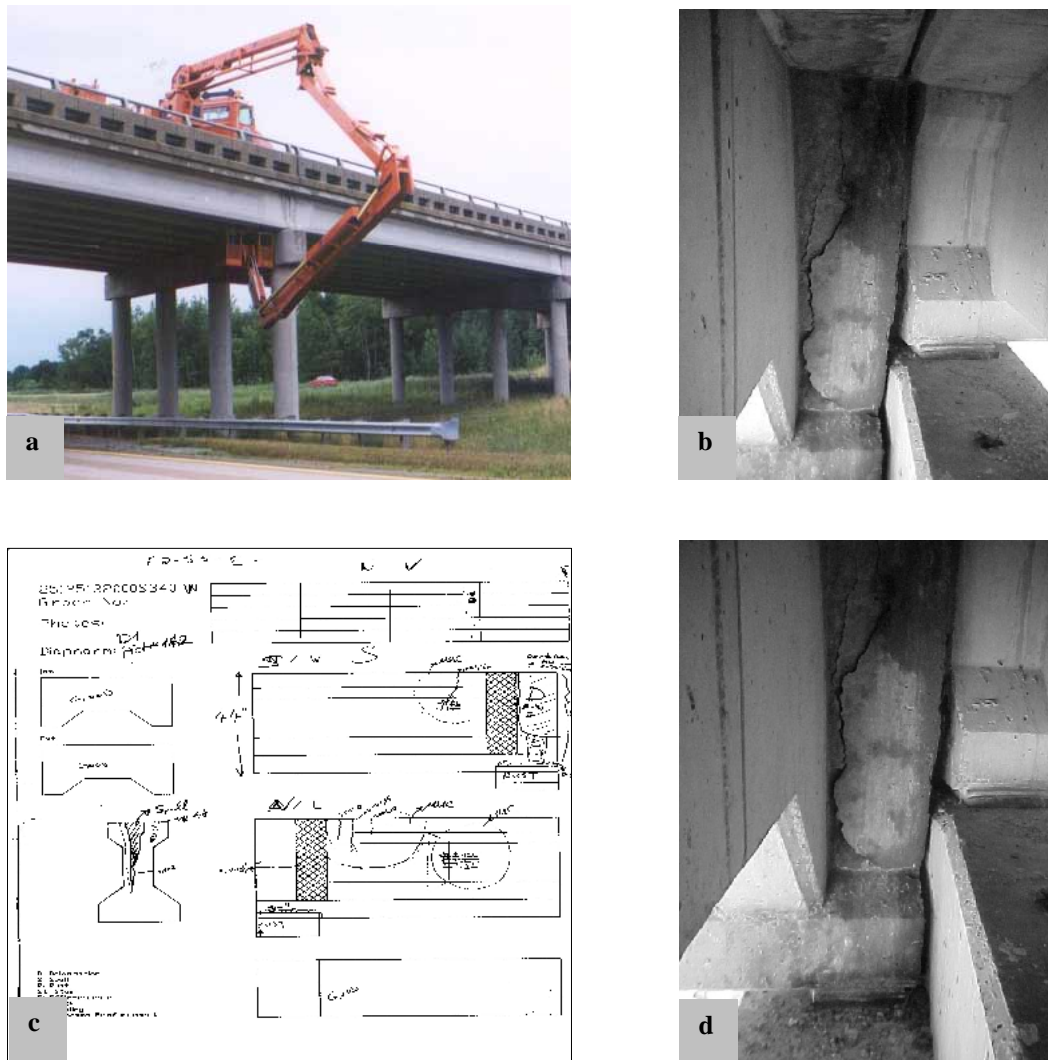
As an example of the template use, consider the beam-end condition of one of the inspected bridges (bridge ID 06111-S110) shown at Figure 4-a. The typical beam-end condition of this bridge is shown on Figures 4-b and 4-d. The difference in the conditions of two beam-ends is due to variation in restrains at the beam-ends, bearings and the deck condition. On the template form, Figure 4-c, all faces of the beam-end were inspected and all signs of deterioration were documented on the form. Cracks were drawn to a rough approximation with respect to their length, location, and orientation. Corrosion, delamination, spall, water stain, efflorescence, and exposed rebar were carefully sketched onto the form to show approximate areas and locations. The data presented on all the field investigation forms is qualitative information, therefore a custom made Microsoft Access database was created to transform that data into quantitative information for analysis.

FIGURE 4 (a) General view of the bridge (ID 25132 S340); (b) Condition of beam-ends of adjoining spans with deck; (c) Field inspection form depicting the beam-end condition; (d) Beam-ends with bearings.

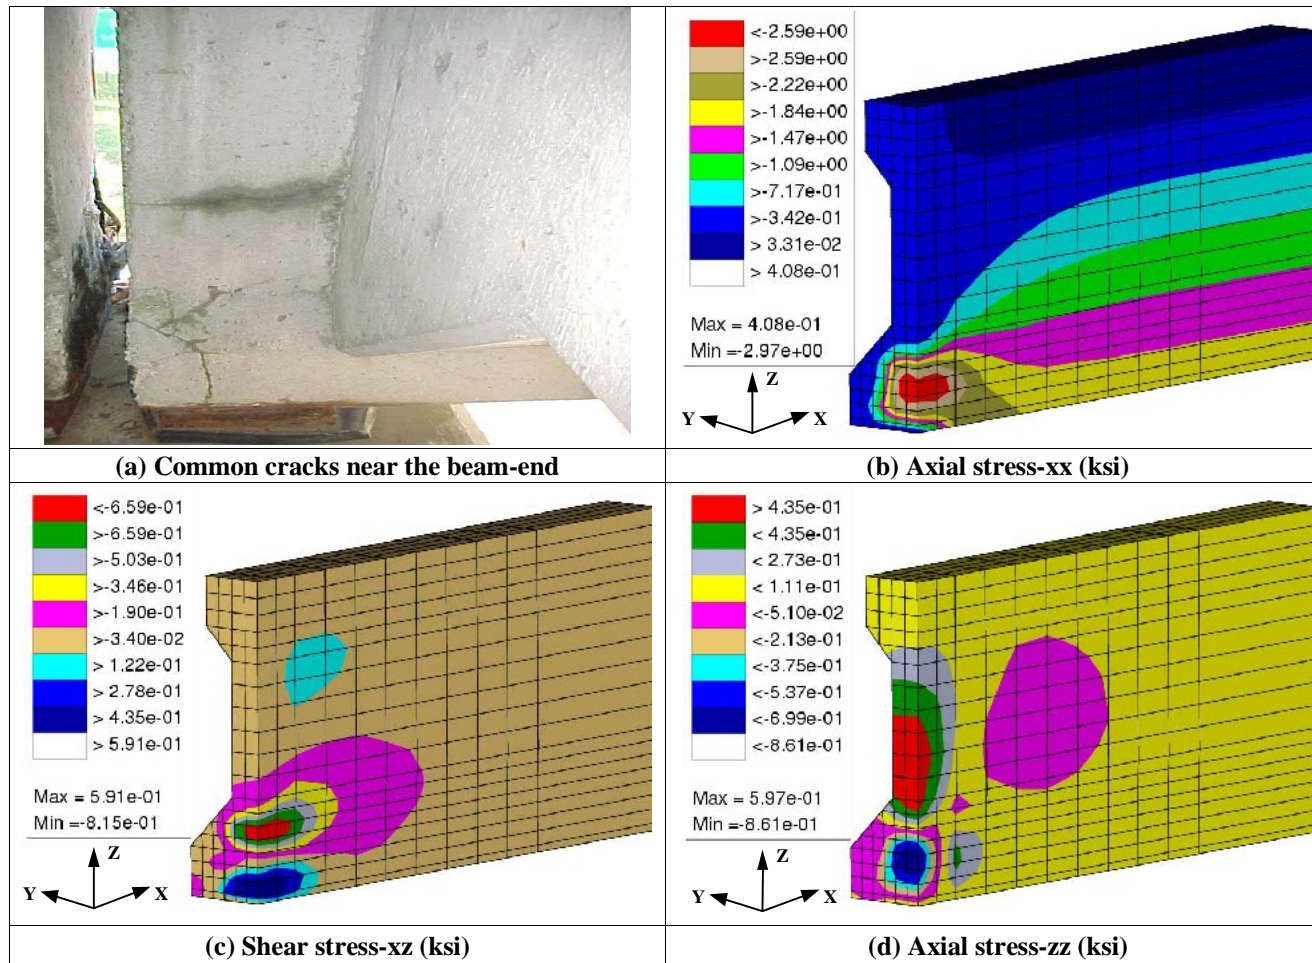
The field investigation revealed that beam-end distress progresses rapidly if cracking is present. Beam-end cracking was observed even in new girders in the plant and on girders of recently built bridges. A 3-D finite element (FE) model of AASHTO PC I-girder was utilized to identify the causes of the cracks appearing in the mid-web and on the transition zone between web and bottom flange, Figure 5-a. A simply supported I-girder, AASHTO Type-III, with a length of 49 feet was modeled using solid elements. Pre-and post-processing was performed by utilizing HyperMesh v5.0, a commercial software package, for preparing the FE mesh. ABAQUS, a finite element analysis program, was employed to solve for the desired outcomes such as displacements, stresses, etc. The results, given in Figure 5-b, 5-c, and 5-d as stress contours, focus on the beam-end for the half of the beam cut along the x-z plane.

Axial stresses in x direction, shown in Figure 5-b, clearly show that the axial and flexural stresses gradually develop within a length termed as the transfer length. As seen in Figure 5-b, the prestressing force is fully transferred to the concrete member between 27.50 in and 34.00 in, after which the axial compressive stresses stay constant. This discrepancy in prestressing force transfer results in shear stresses by generating varying flexural stresses along the transfer length at the beam-end. Concrete material with a compressive strength of 5 ksi and an elasticity modulus of 4,300 ksi is defined in the FE model. A cracking strength of 0.53 ksi is obtained by the formula of $7.5\sqrt{f_c'}$ for normal weight concrete (8). It can be construed that cracks on the transition zone between web and bottom flange are due to the shear stresses developed on xz plane at locations where the stresses are around 0.82 ksi, as seen in Figure 5-a and 5-c. It should be noted that the absolute values are of importance for the assessment of cracking potential in Figure 5-c. The analysis also revealed that mid-web cracks are due to the tensile stresses generated by Poisson's effect in z direction near the beam-end, as shown in Figure 5-a and 5-d.

FIGURE 5 (a) Common cracks near the beam-end; (b) Axial stress-xx (ksi); (c) Shear stress-xz (ksi); (d) Axial stress-zz (ksi).

Elements under uniaxial loading show lateral deformation due to Poisson's effect. When lateral reinforcement is provided, it generates passive pressure around the concrete inside the reinforcement by preventing the lateral deformations (9). Therefore core concrete is loaded triaxial instead of uniaxial. As a result, member strength and shear capacity are increased. For beam-end stresses within transfer length due to prestressing transfer, if adequate reinforcement is supplied, the shear capacity of the member will be improved. Member end confinement is recommended also in the literature and the codes (8,9) as a remedy for bursting cracking. In order to eliminate or reduce the cracking potential at the girder ends, the stirrups especially within the bottom flange should be closed to provide lateral confinement. Welded wire mesh reinforcement may also be used as confinement steel.

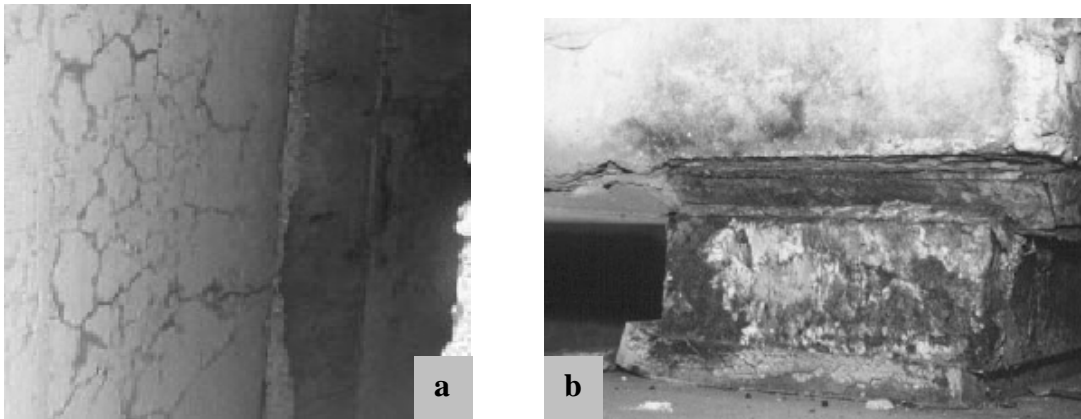
FIGURE 6 (a) Hairline and Mapping cracking; (b) Bearing Condition (Condition state 6).
